Table of Contents for 2818 Rio Grande Tree Permit
Heritage Tree Variance Package

PROJECT NAME: 2818 Rio Grande

TREE PERMIT #: 10827869

REQUEST: The applicant is requesting to remove a heritage tree with a stem greater than 30" in diameter.

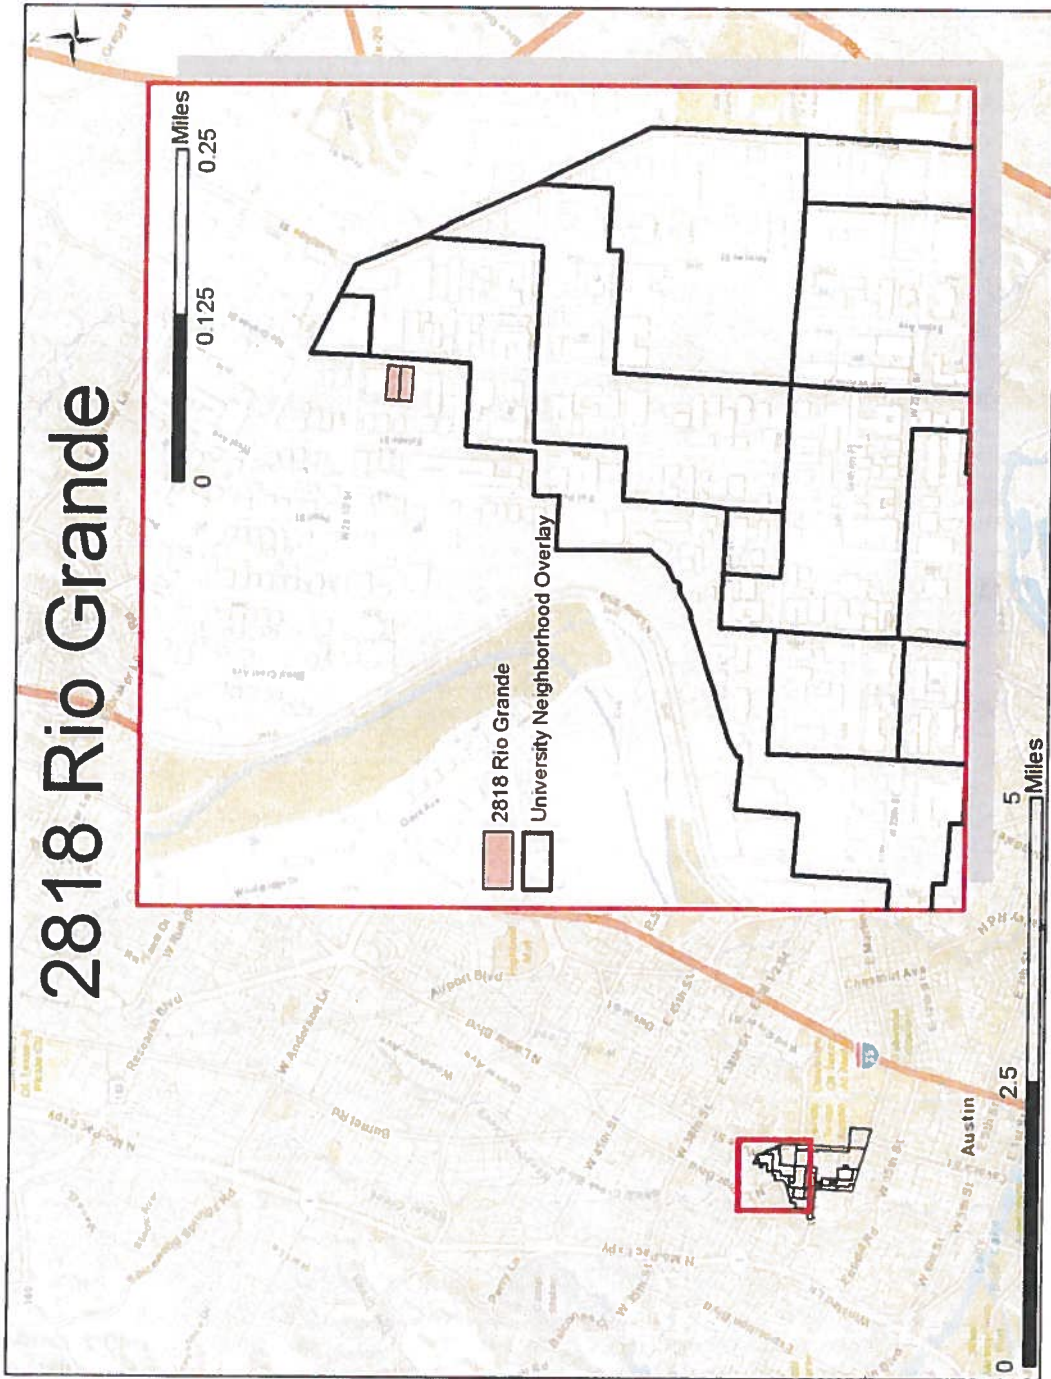
Exhibit 2

The subject property is comprised of two lots located at 2818 Rio Grande (Exhibit 1). The zoning is MF-4 and is adjacent to, but not in, the University Neighborhood Overlay District (UNO) (Exhibit 2). The zoning allows for 60 feet building height, .75:1 FAR, and 70% impervious cover. The desired use is an apartment building. The property is located in the Shoal Creek Watershed and is subject to urban watershed regulations.

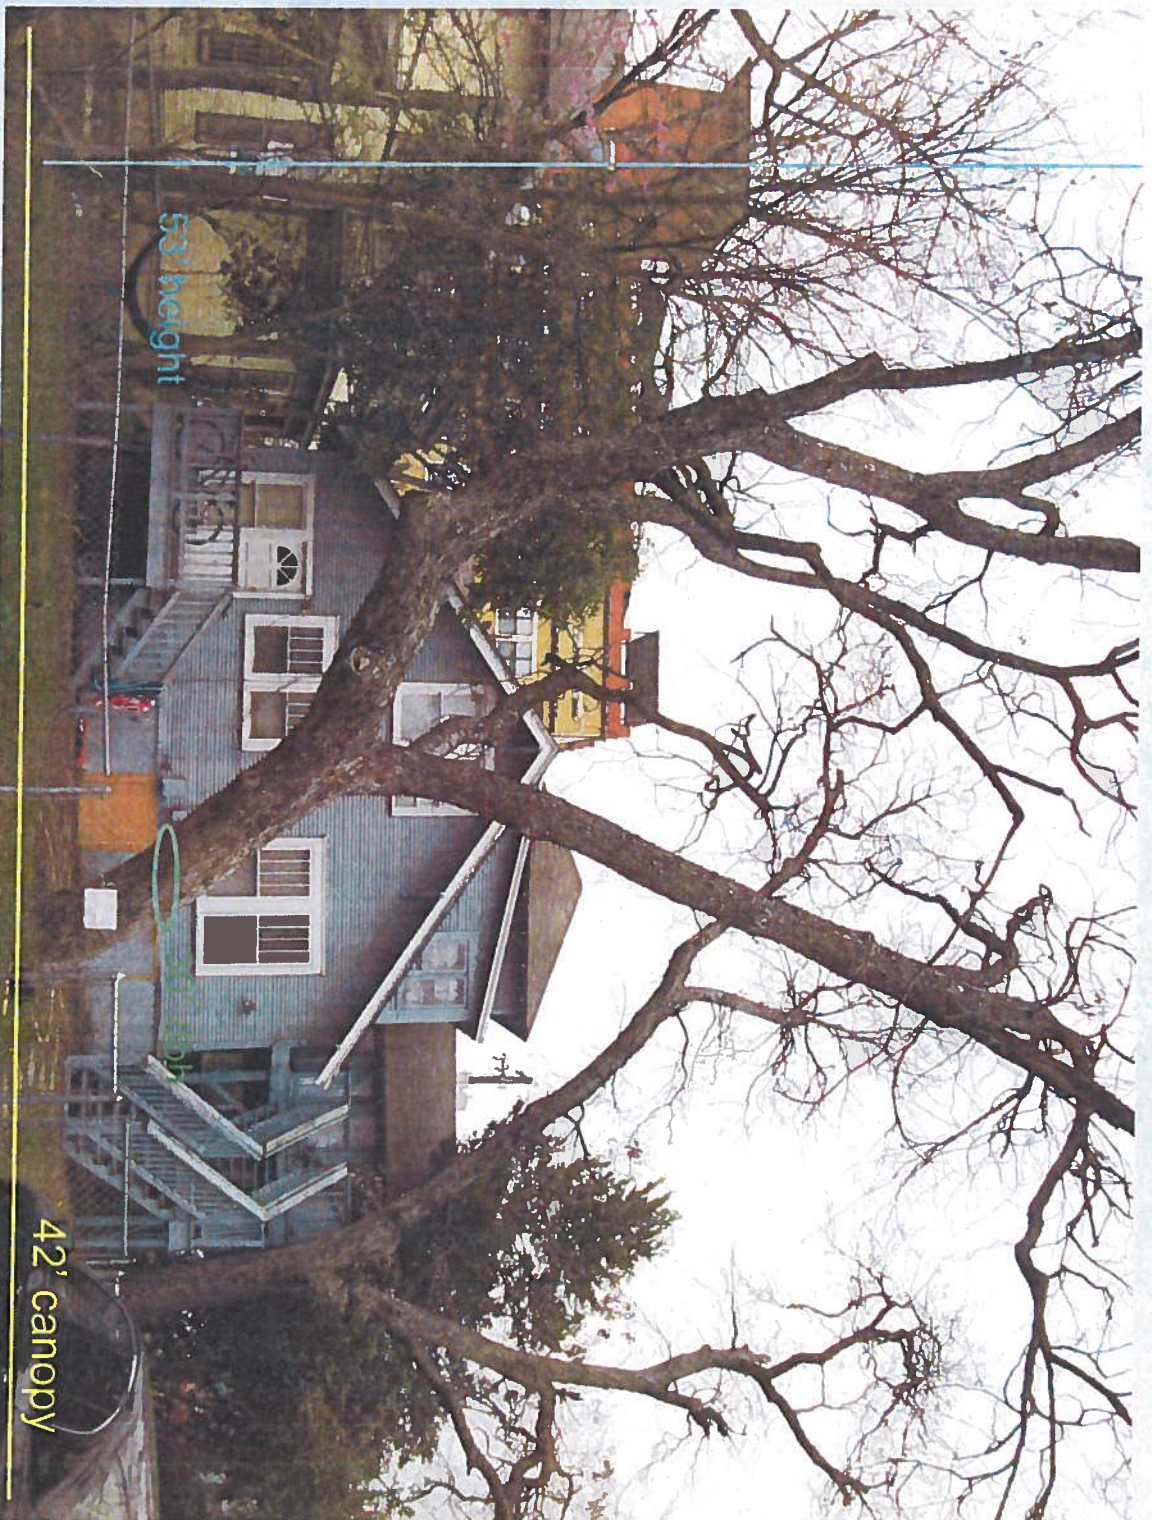
Exhibit 3

The subject tree is a 30.0 inch diameter at breast height (dbh) Pecan (*Carya illinoensis*). The tree height is 53 feet and the canopy spread is 42 feet (Exhibit 3). The tree has a 45 degree lean from vertical with no evidence of root decay or soil heaving (Exhibit 4).

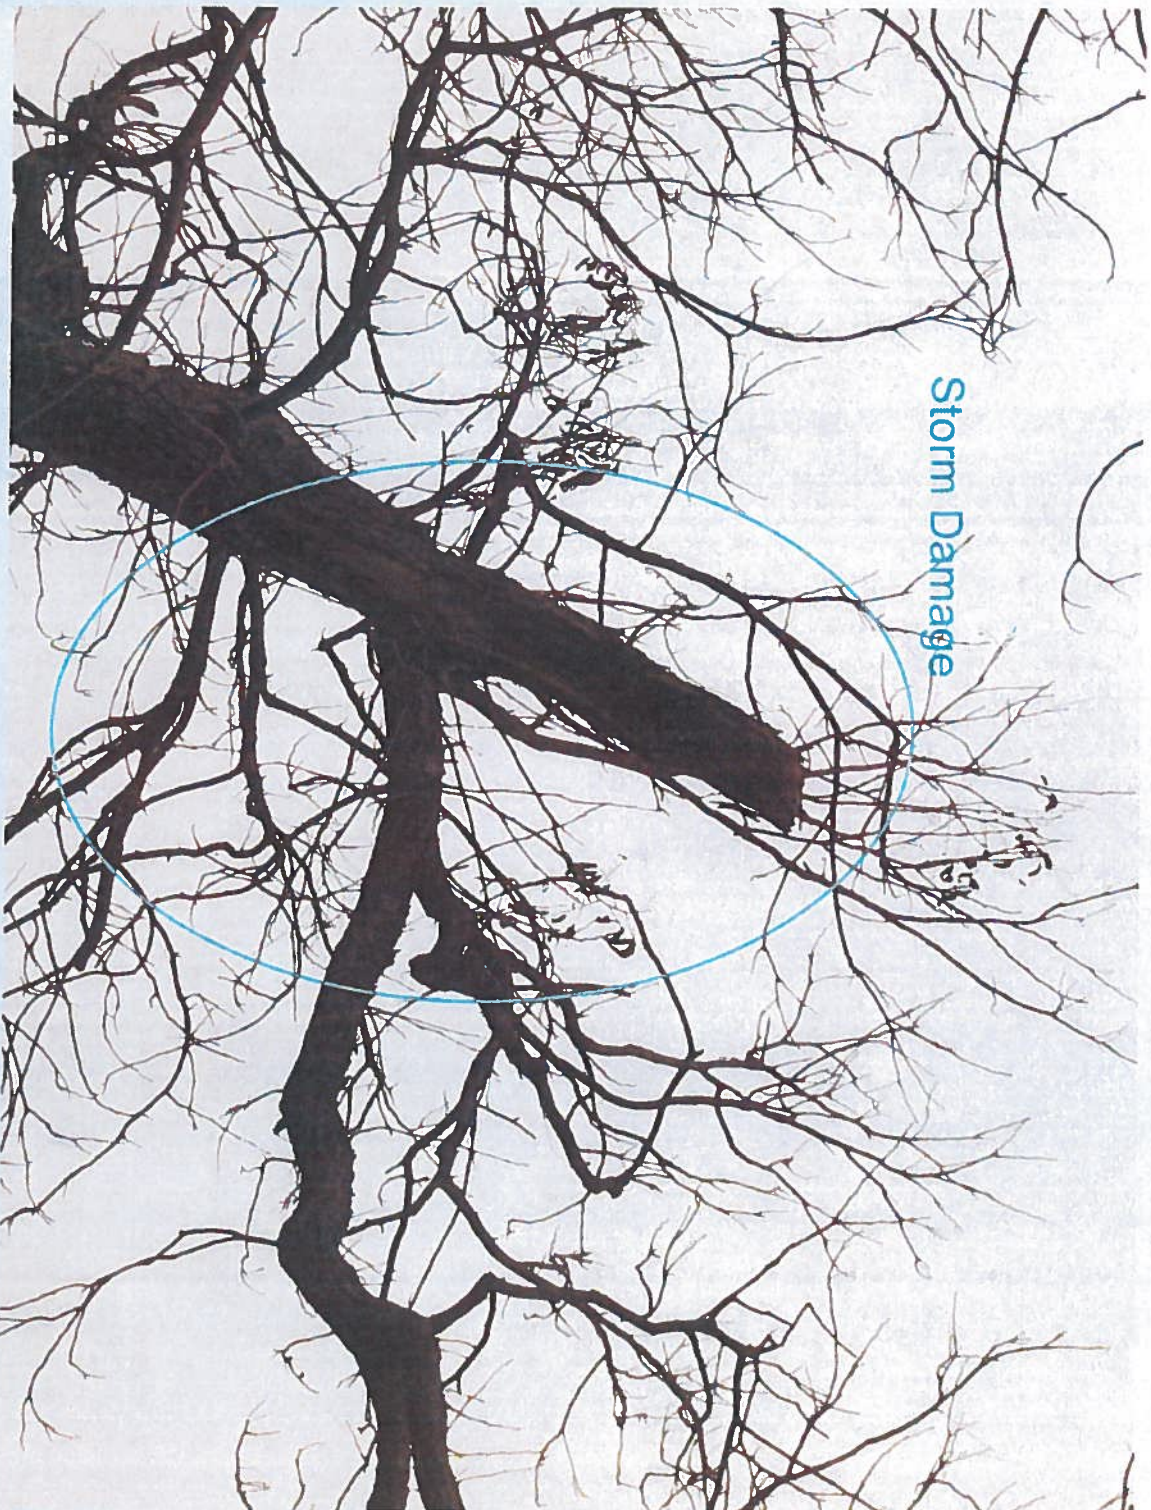
Exhibit 5

The canopy has major asymmetry, extensive storm damage, and moderate decay. Storm damage is evident by the presence of multiple broken stems and subsequent decay (Exhibits 5,6,7 and 8).

Storm
Damage

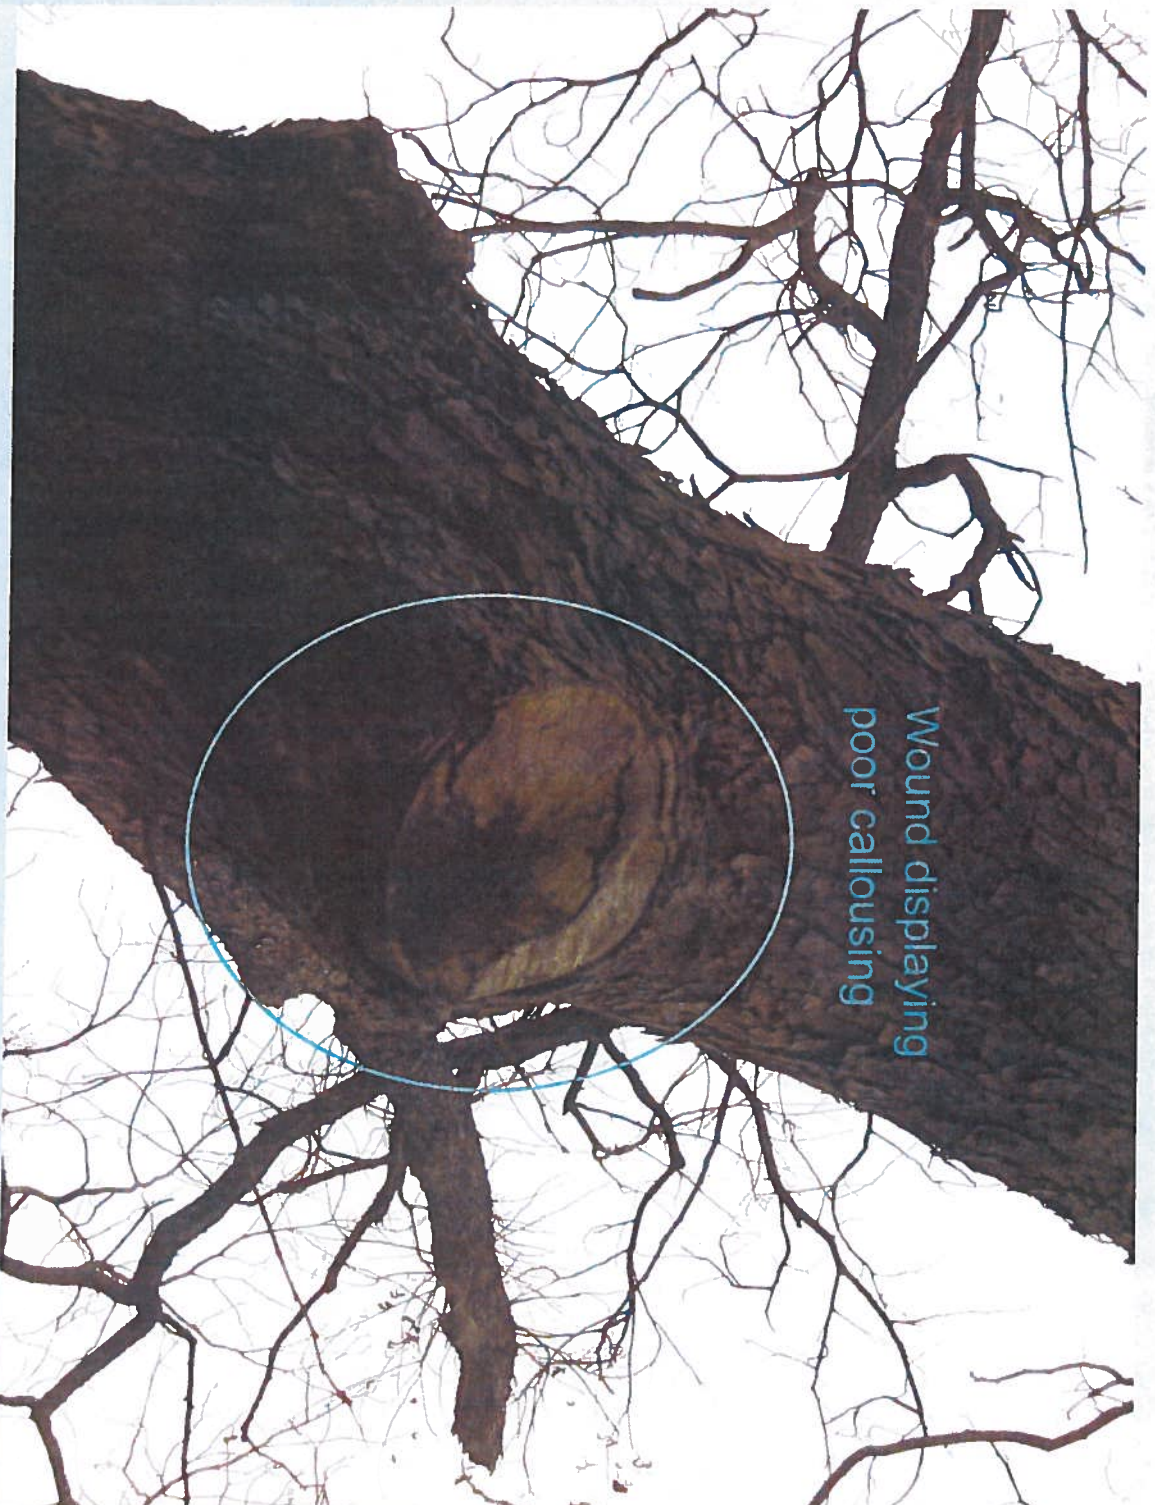
Exhibit 7

Wound displaying
poor callousing

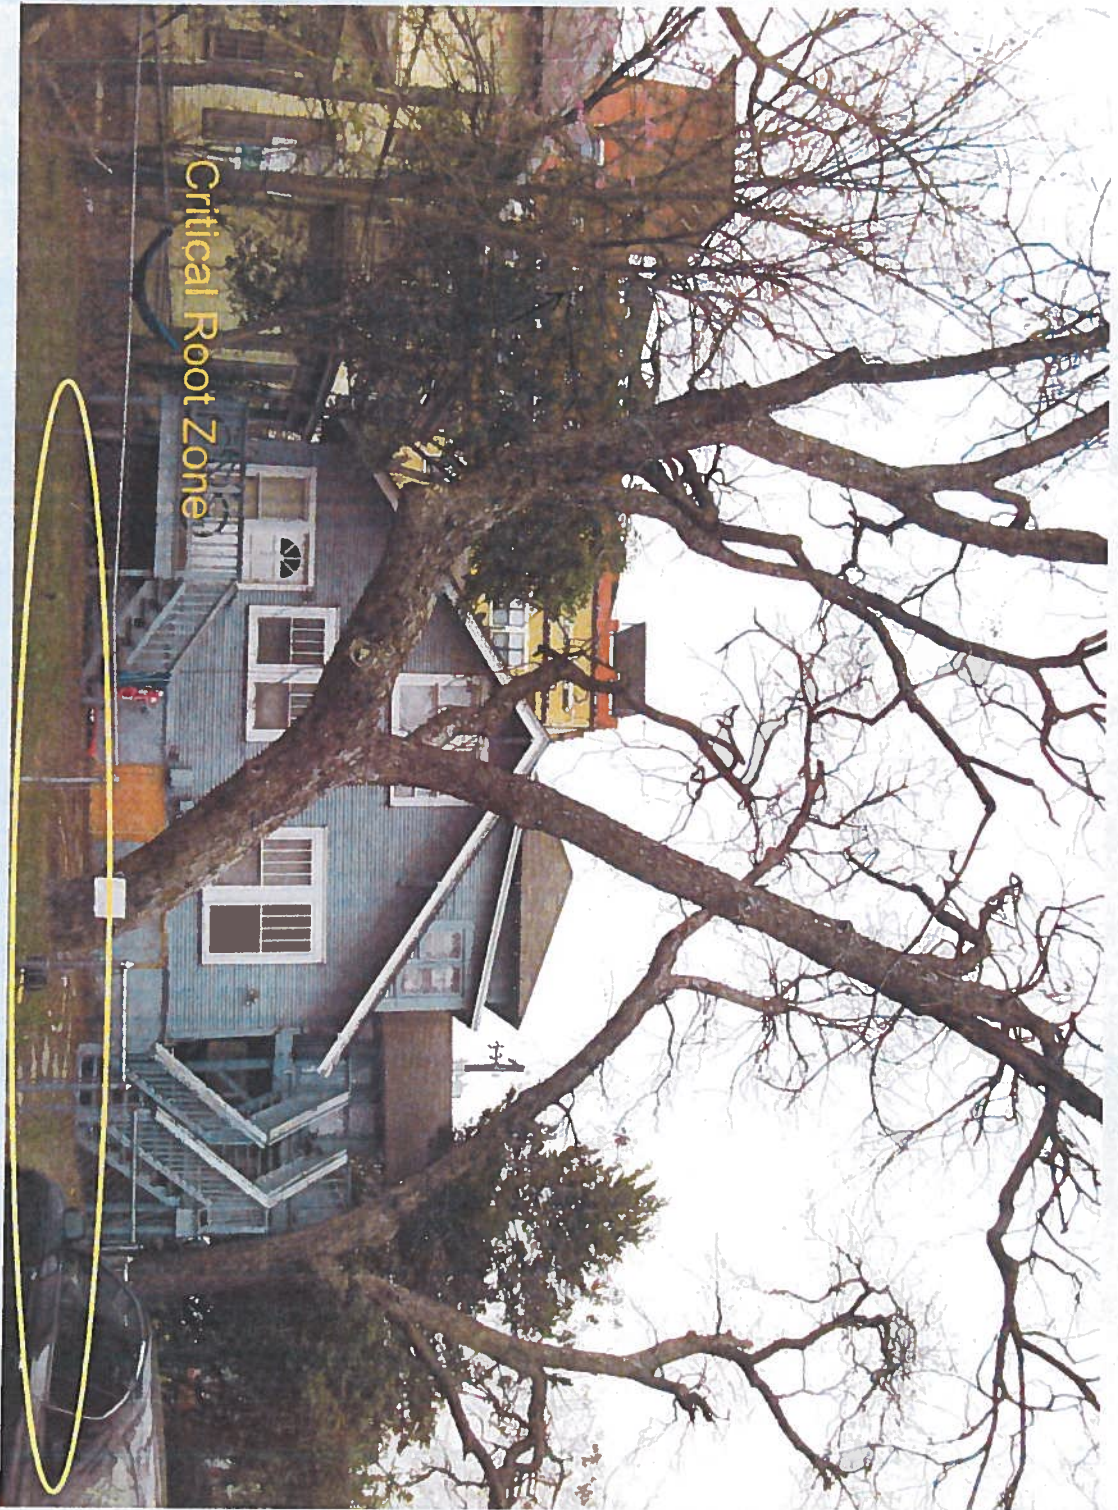
Exhibit 9

Critical root zone conditions are characterized by compacted turf grass and bare soil, base material serving as a parking lot, and a housing structure (Exhibit 9). Root flare is present with no signs of wounding or decay.

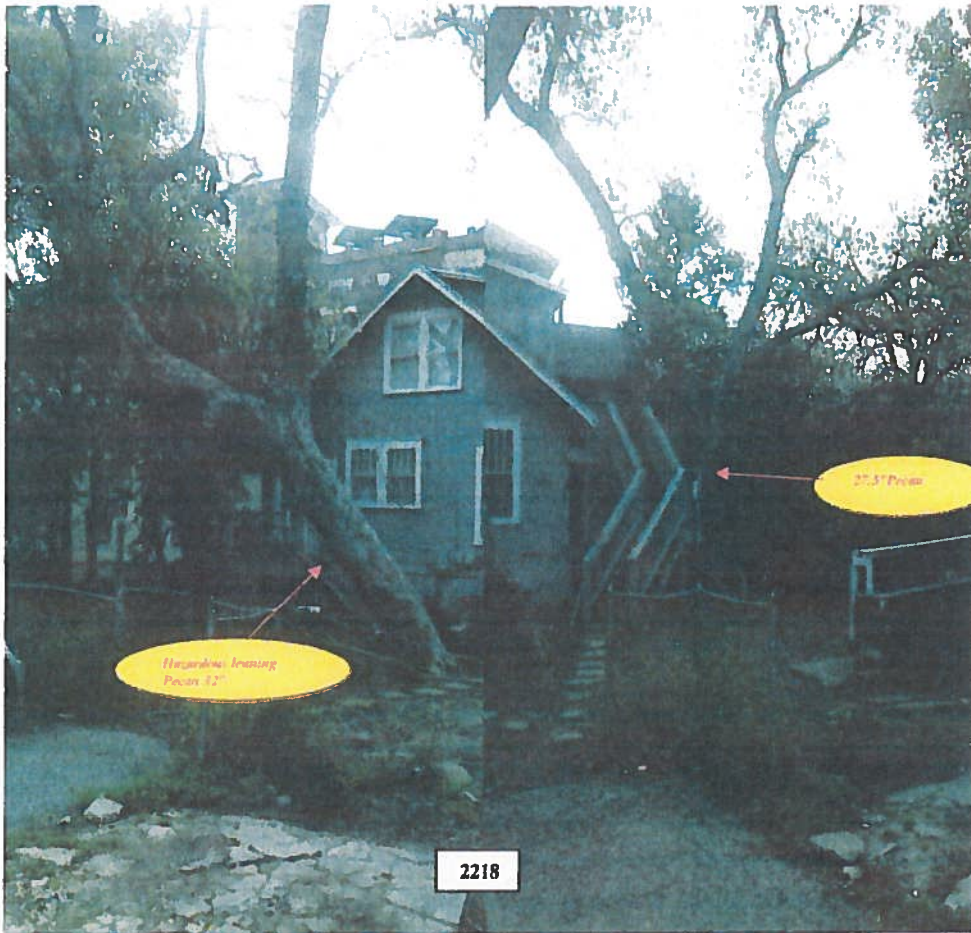
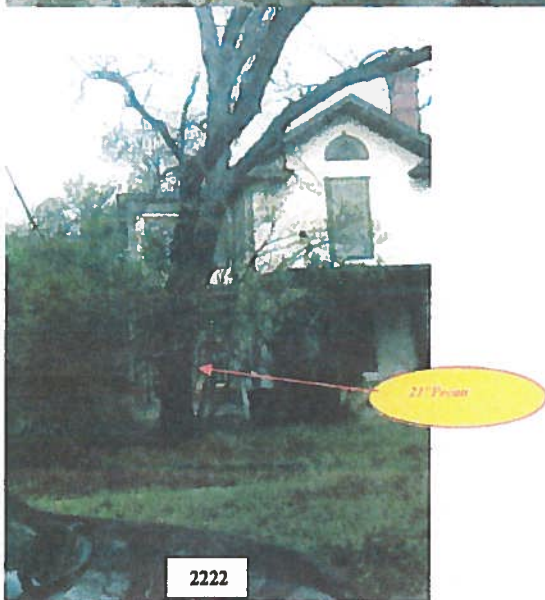
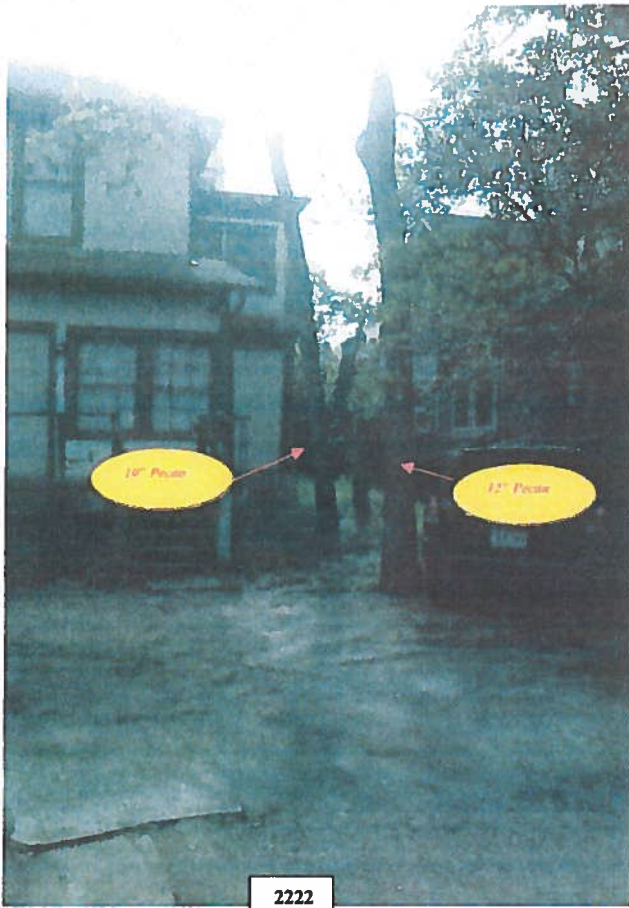
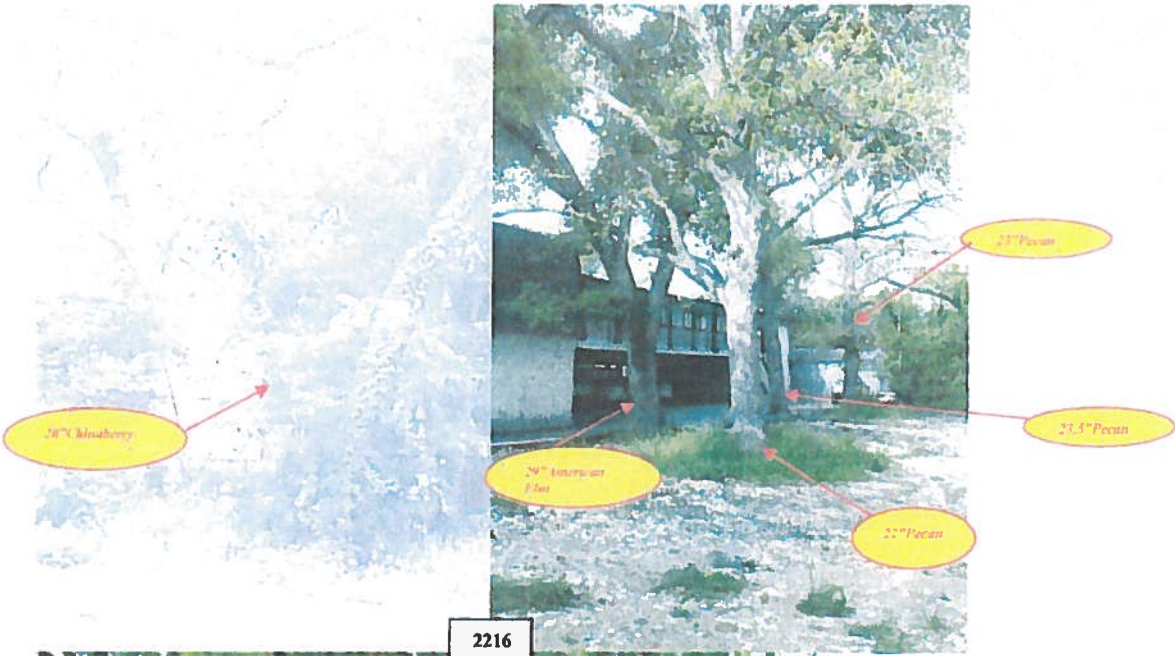
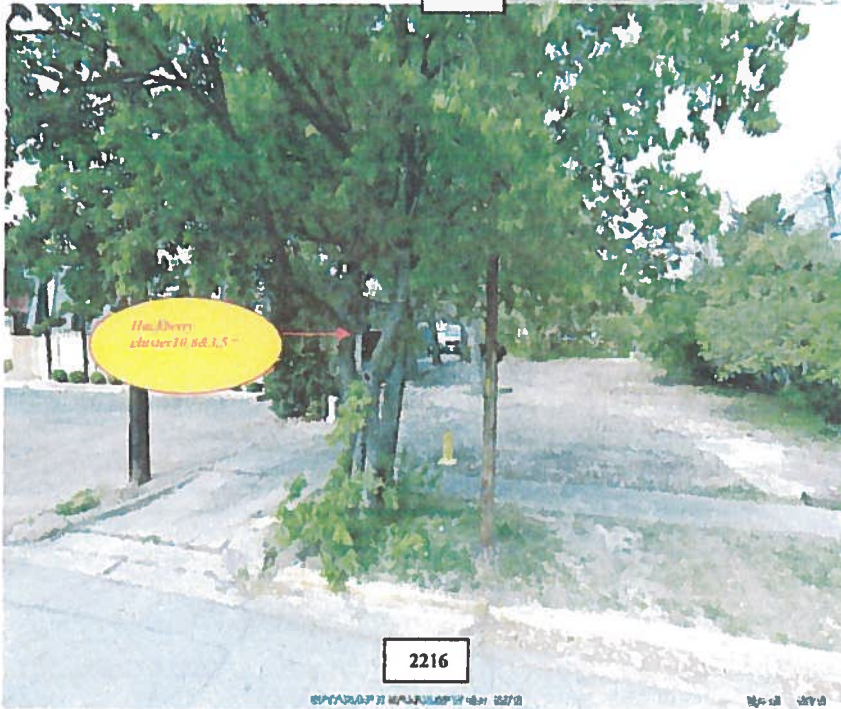
- ❖ American Elm Tree 29" (*Ulmus americana*) is considered- Average- in- condition.
- ❖ All Pecan Trees (*Carya illinoensis*) are in Above Average- to- Excellent in condition; *With the exception of the 32" on lot 2218, NOTE: it is leaning at a 45 degree angle and is very top heavy, This Pecan tree needs to be removed. Due to the liability. It is Poor in condition. (see photo).
- ❖ Cluster of Common Hackberry Trees (*Celtis occidentalis*) in City right-of- way, are weak and considered Poor- in- condition.
- ❖ Chinaberry Tree 20" (*Melia azedarach*) is considered an invasive species
- ❖ Remaining Trees and shrubs are less than 8" can be removed without tree permit.
